A common problem with the 2023 is the main plugs leading to the backrest vibrating loose, this is a very simple item to check.

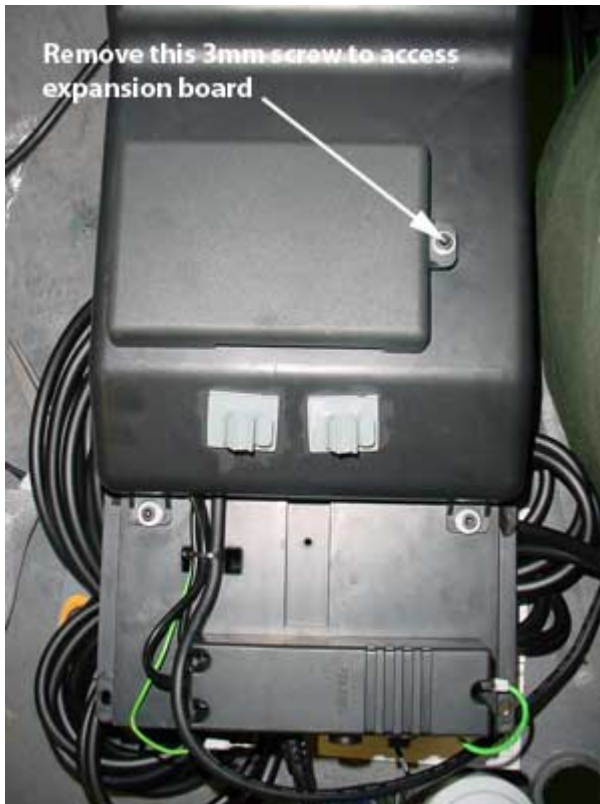
Step 2 Remove the 3mm allen screw holding the cover onto the main PCB expansion board.

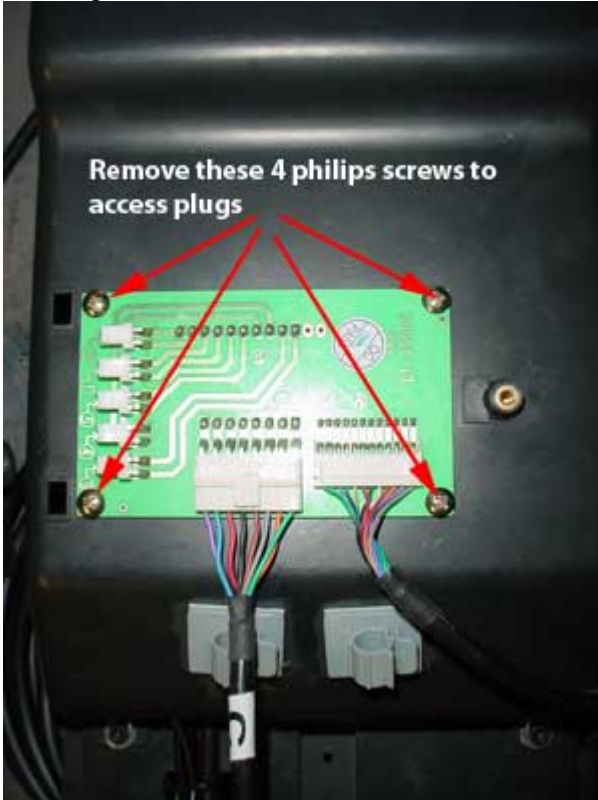
Step 3) Remove the 4 philips screws holding the expansion board the the Main PCB housing.

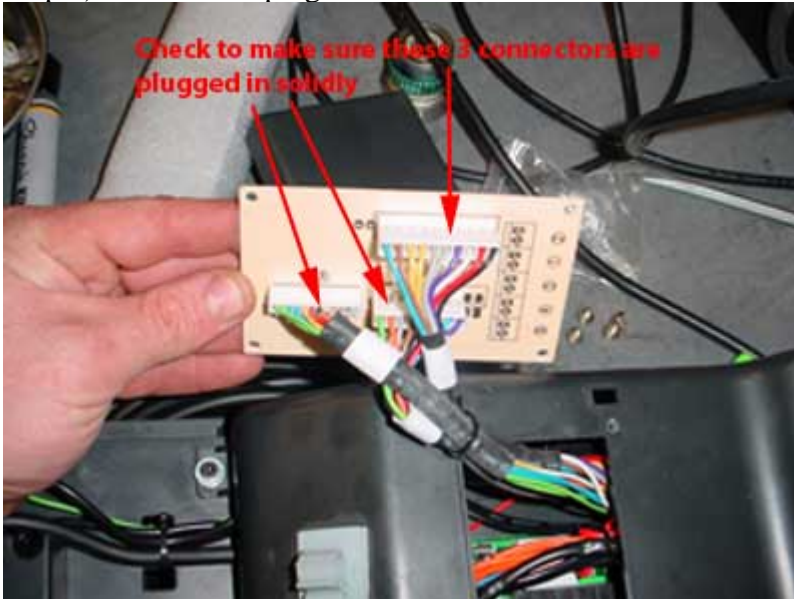
Step 4) Check the 3 plugs located on the bottom side of the expansion board.
