PHP 2026 / 2027

Replacing the Footrest Extension Handle Pivot Stud

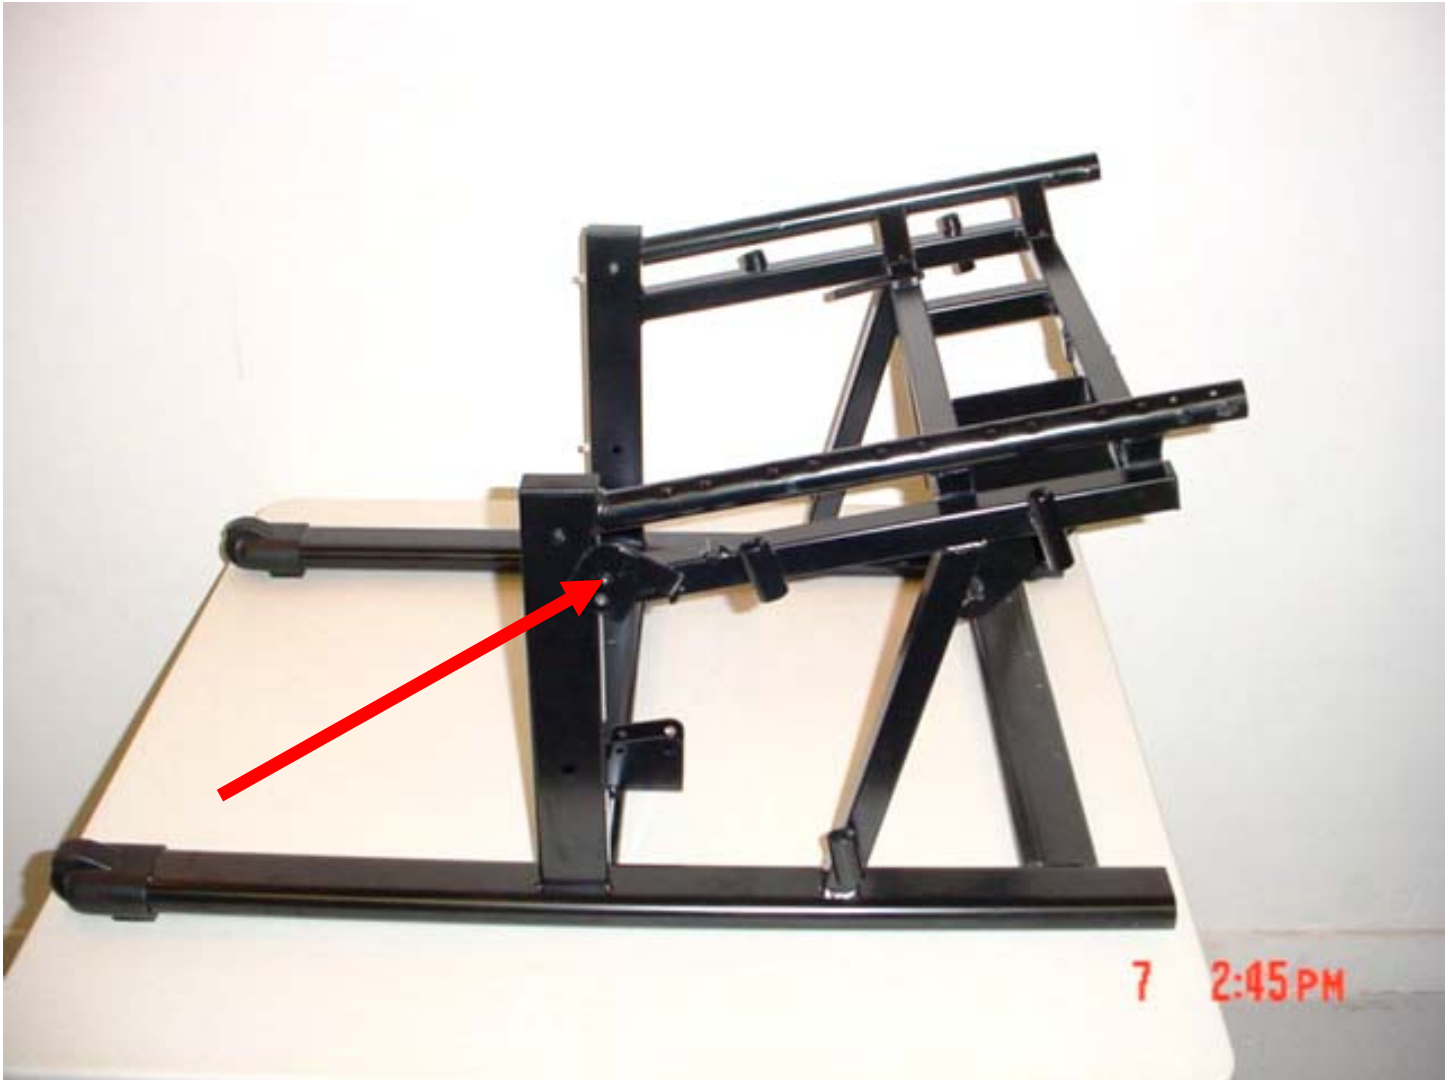
This procedure **DOES NOT** require removing the upholstery and other parts from the frame. It is shown this way for clarity.

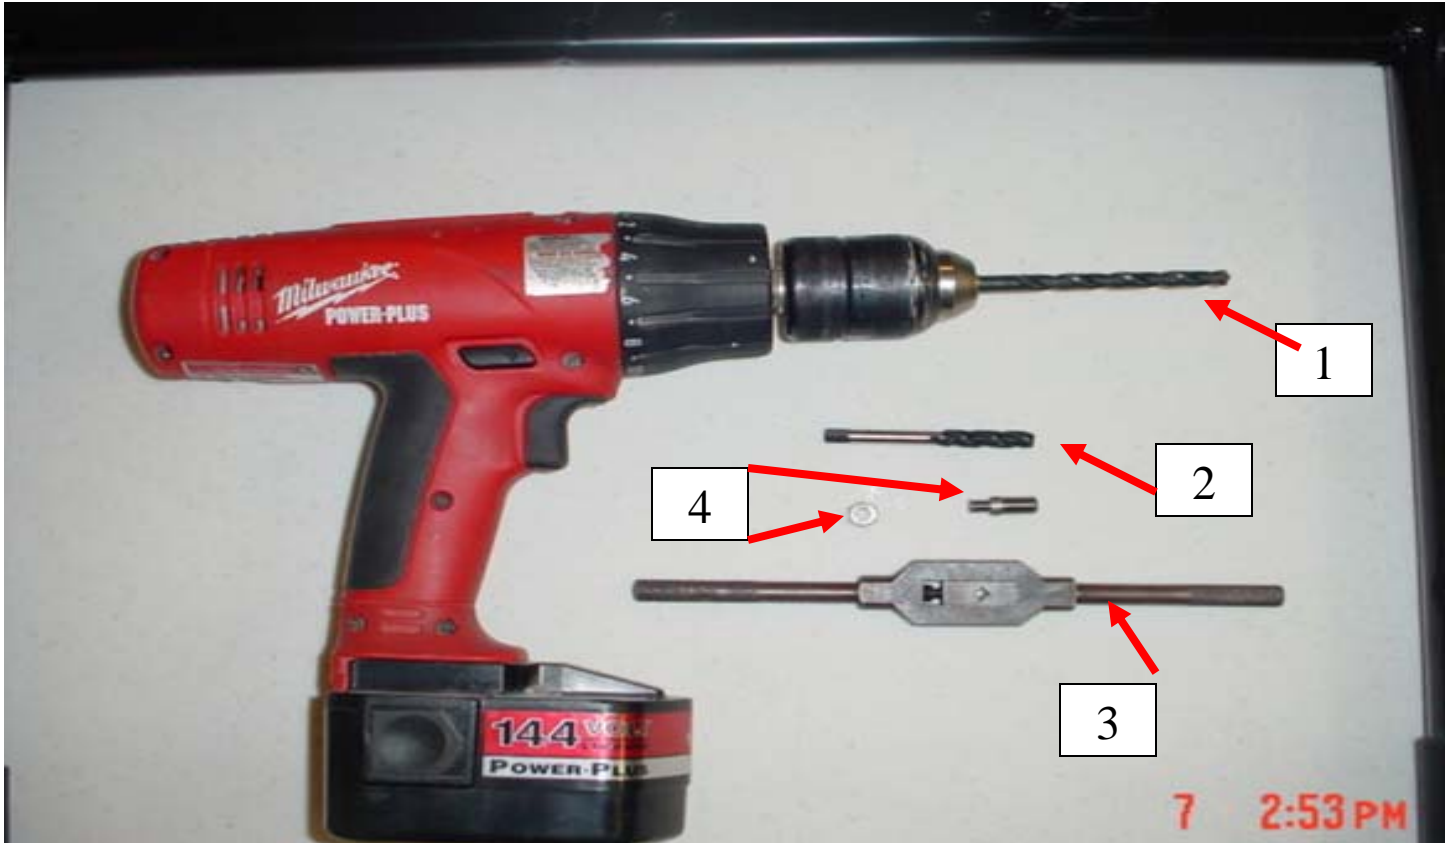
TOOLS

We have provided you a basic tool kit which includes:

- 1) 6.8 mm drill bit (= 17/64 inch)
- 2) 8mm x 1.25 tap
- 3) tap handle
- 4) replacement screw-in stud and 10mm nylon-lock nut.

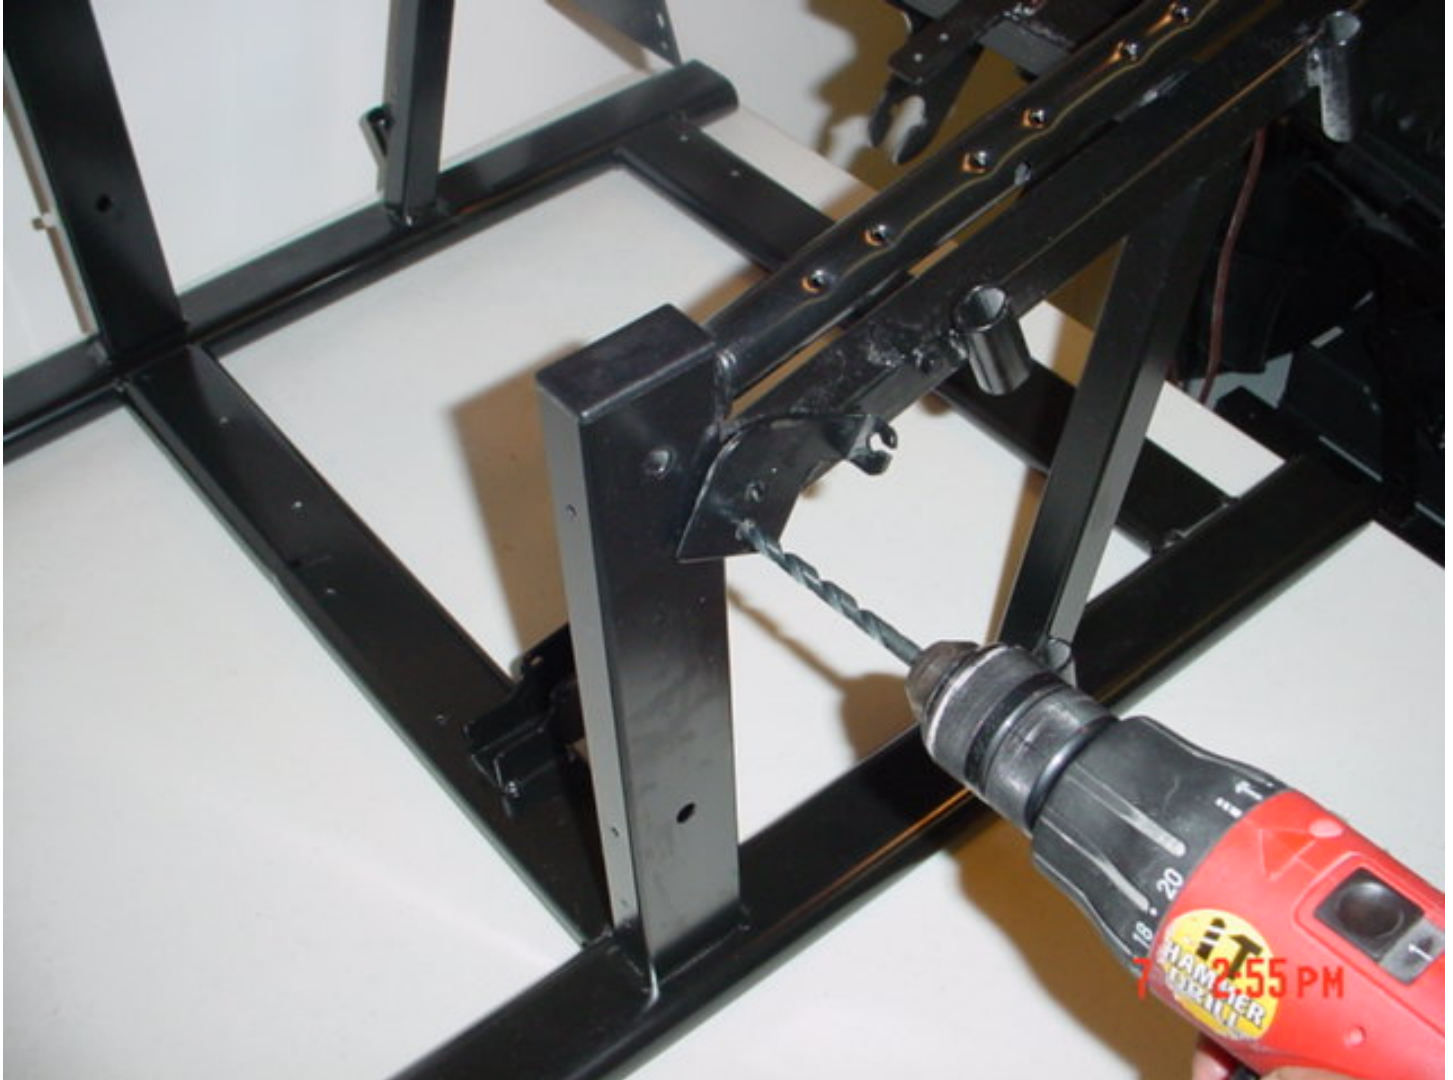
Drilling the hole / broken stud out

The next step is to drill out the hole and any portion remaining from the broken stud. It is helpful at this point to use a small amount of WD 40 or 3-in-1 oil in the hole to lubricate the drill bit to prevent scorching. Remember you are drilling out the hole where the stud was attached to the bracket, *AND* are also drilling a new hole in one side of the square frame tubing itself. It's important to keep the drill at a 90 degree angle as best as possible. Be sure and clean up the small bits of metal to prevent them from getting into any parts of the chair.

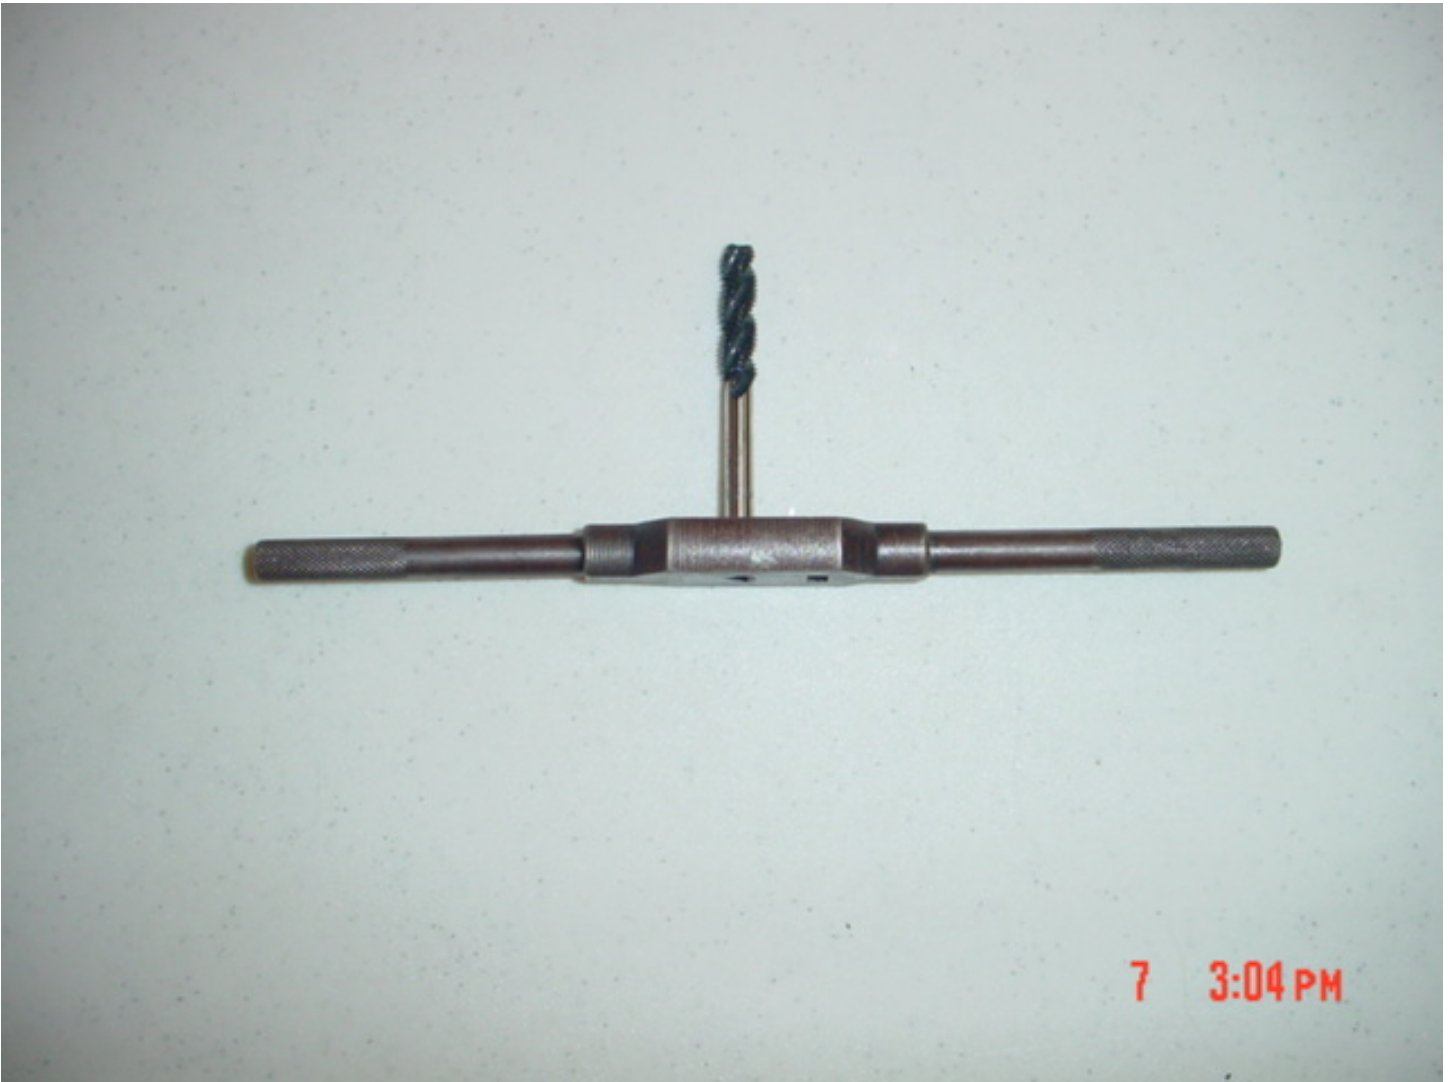
Tapping the hole to accept the new threaded stud.

Insert the tap into the T-handle and tighten securely.

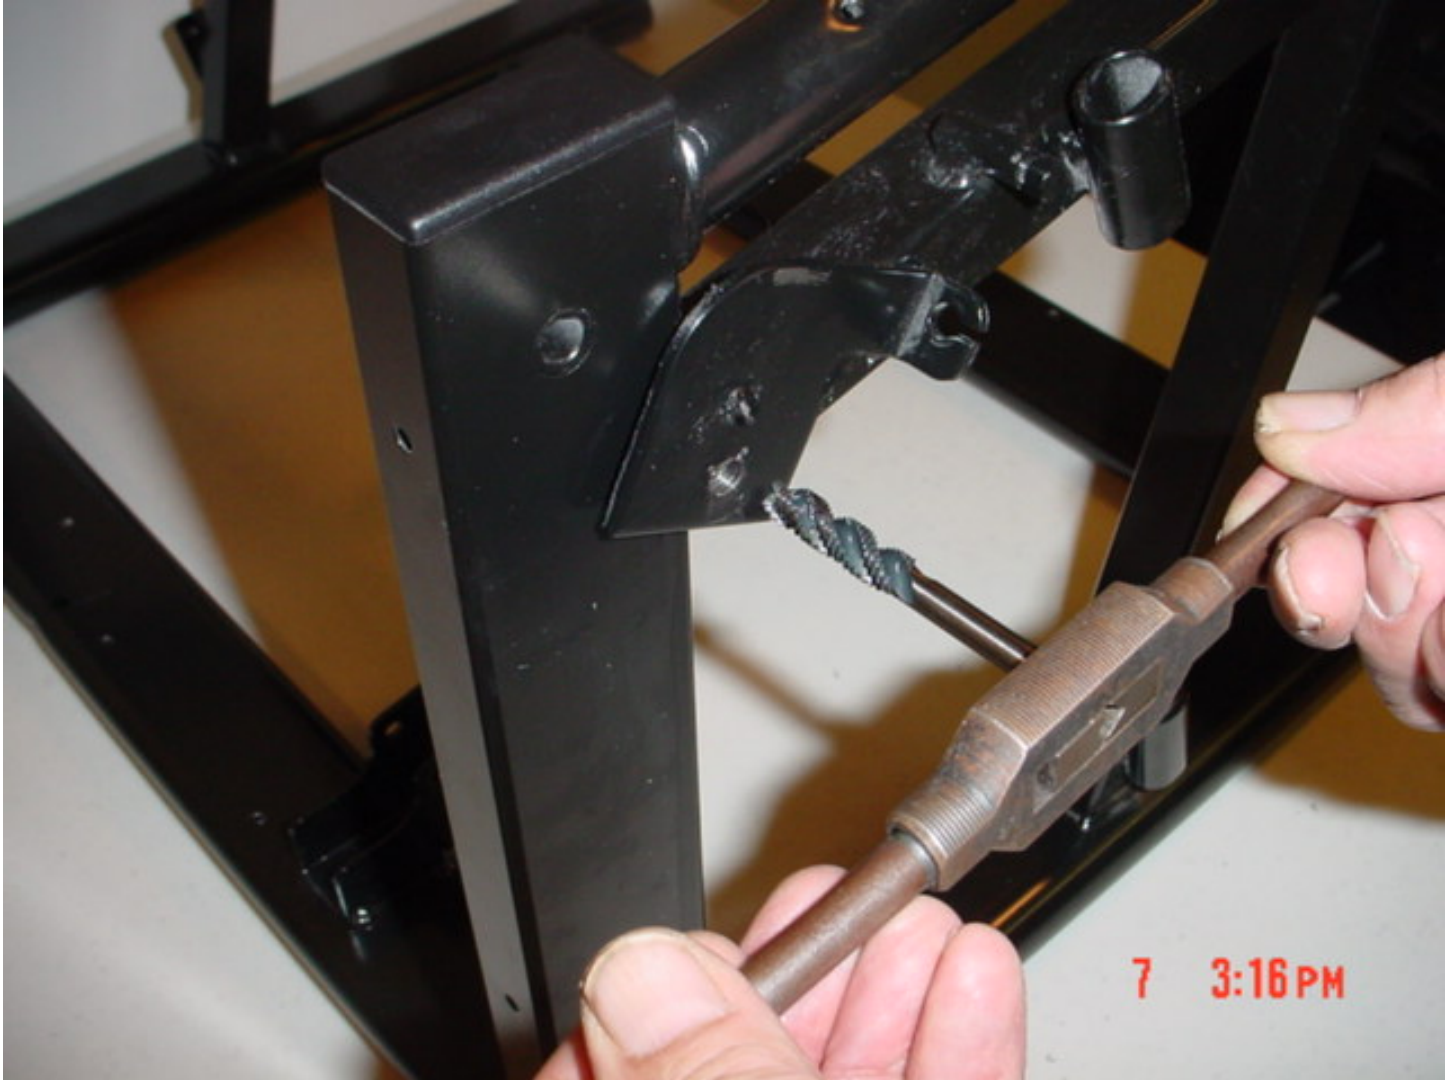
Tapping the new hole to accept the new threaded stud.

Begin by putting a bit of oil on the end of the tap and in the hole. Then insert into the hole.

Begin tapping (threading) by turning the tap clockwise about $\frac{1}{2}$ turn, then stop, and reverse by about $\frac{1}{4}$ turn, but don't remove the tap.

Continue this process until the new hole is threaded completely through the new hole. This can be tedious and may take several minutes to complete. Continue adding a bit of oil as necessary. **DO NOT** turn the tap clockwise more than about $\frac{1}{2}$ turn at a time

After each $\frac{1}{2}$ turn clockwise, reverse the tap about $\frac{1}{4}$ of a turn.

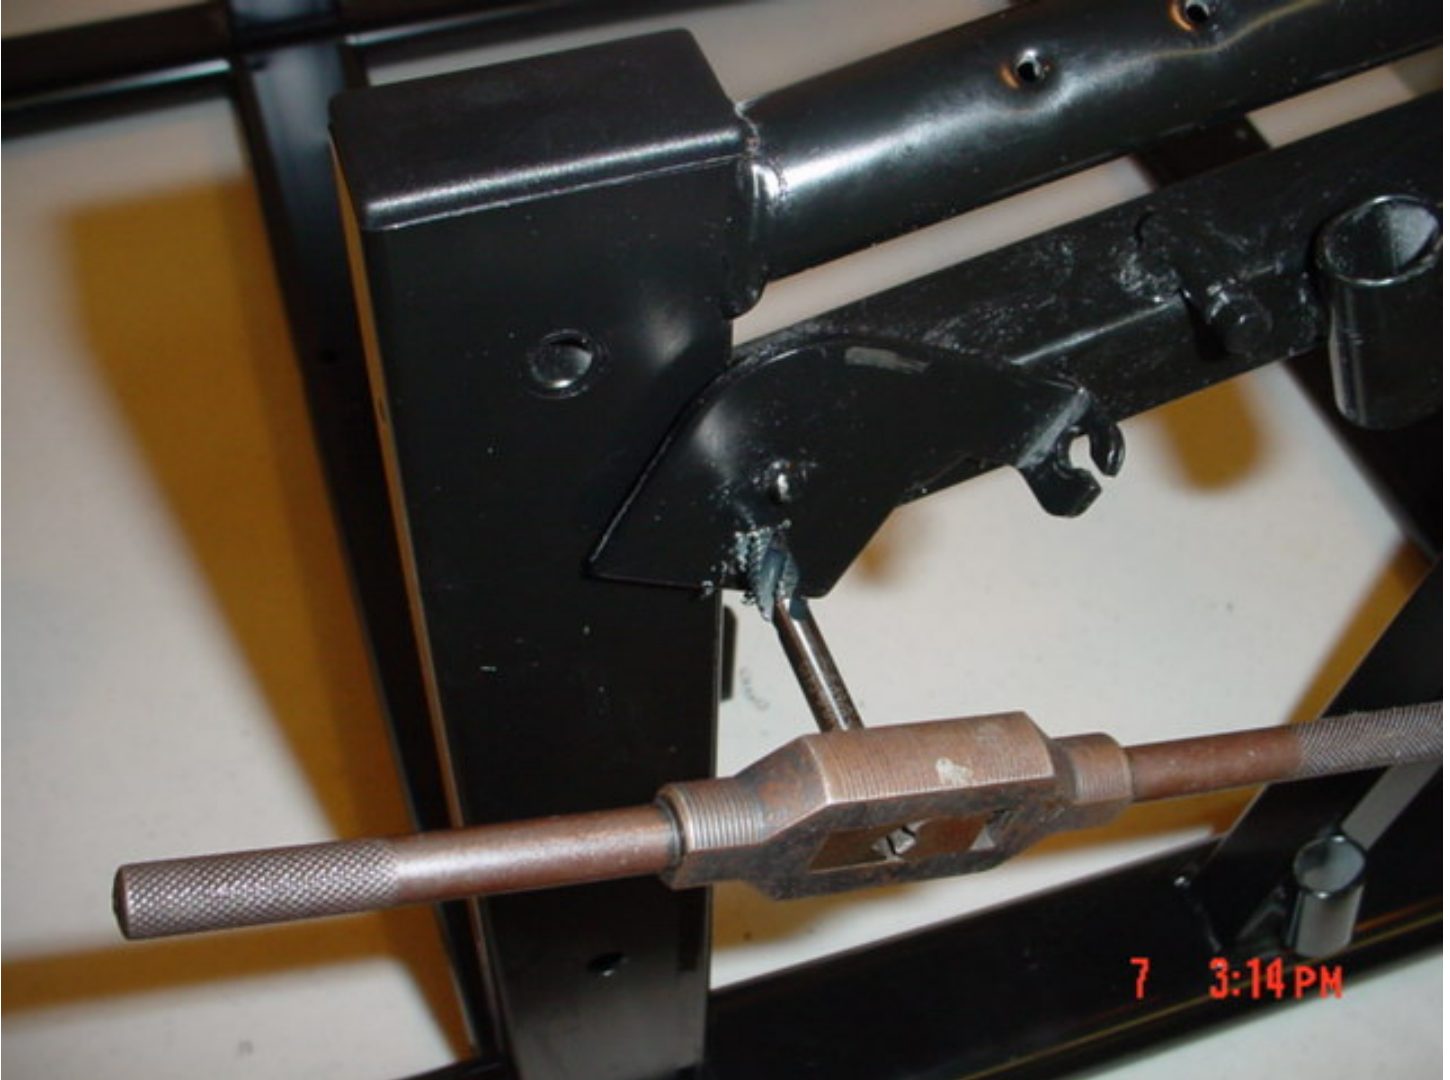
Tapping the new hole to accept the new threaded stud.

When the threading is complete, there should be about $\frac{3}{8}$ to $\frac{1}{2}$ " of the tap sticking into the hole.

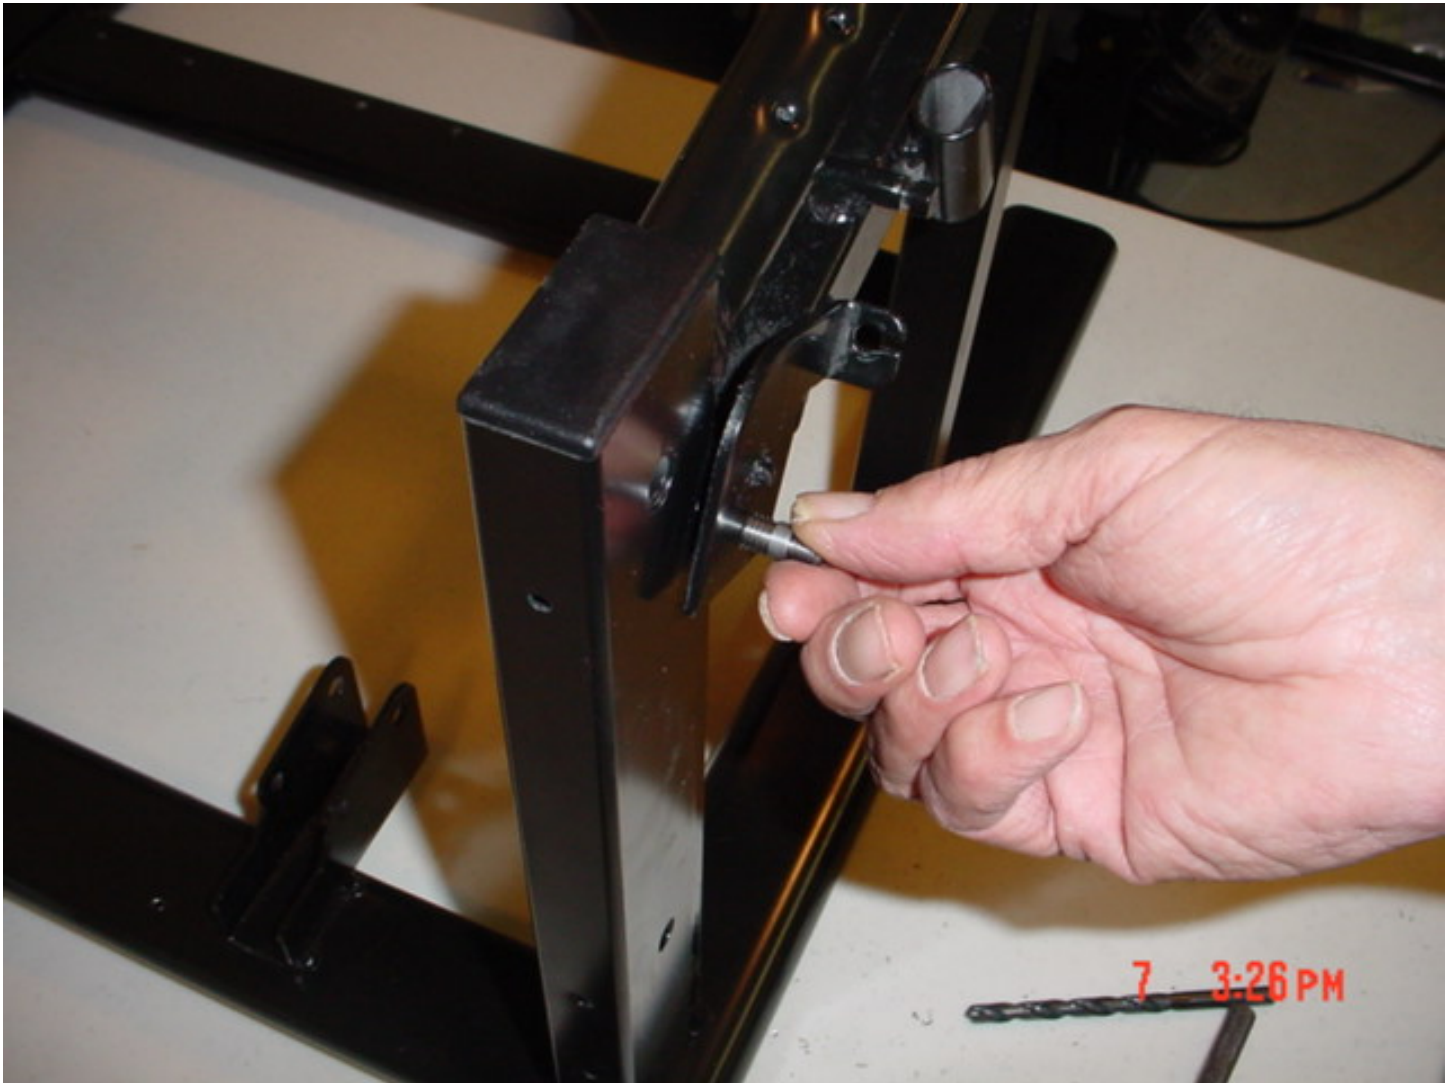
Insert the large end of the threaded replacement stud in the hole, and turn it clockwise. It is recommended to add a drop or two of thread lock prior to screwing in the stud.

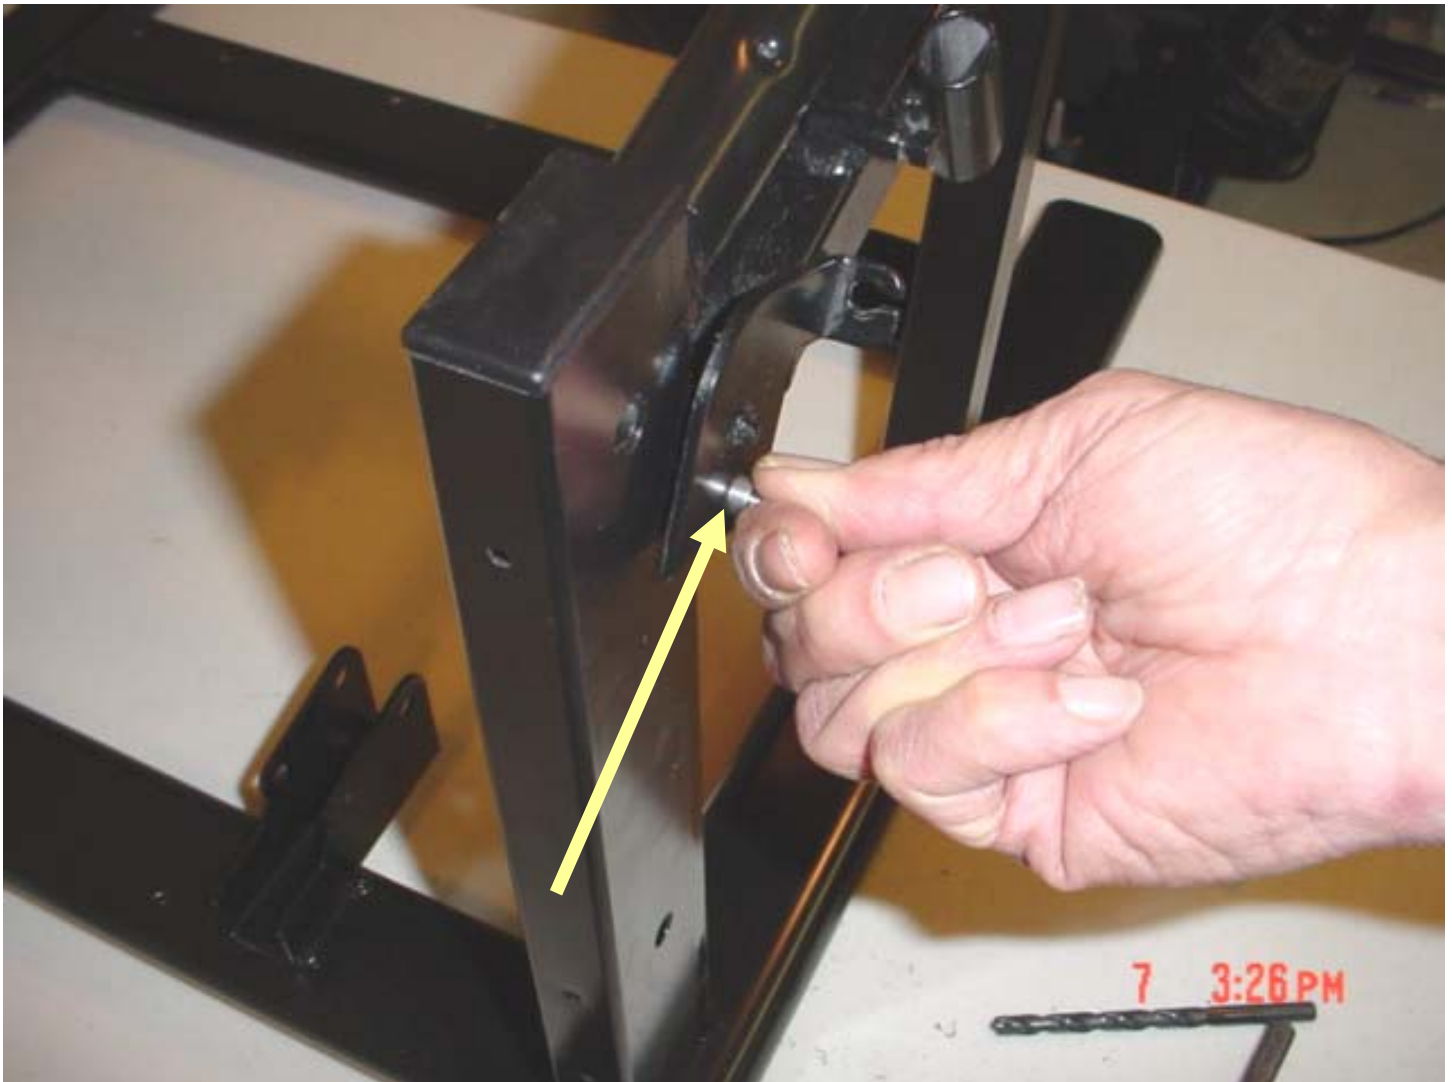
Continue turning until the un-threaded 'shoulder' is against the frame. Hand tightening is normally sufficient. When you replace the Footrest extension handle on the stud and tighten with the supplied lock-nut, it will tighten down the entire assembly.

If the threaded stud does not thread in by hand, you may need to repeat the 'tapping' process to clean out the threads.

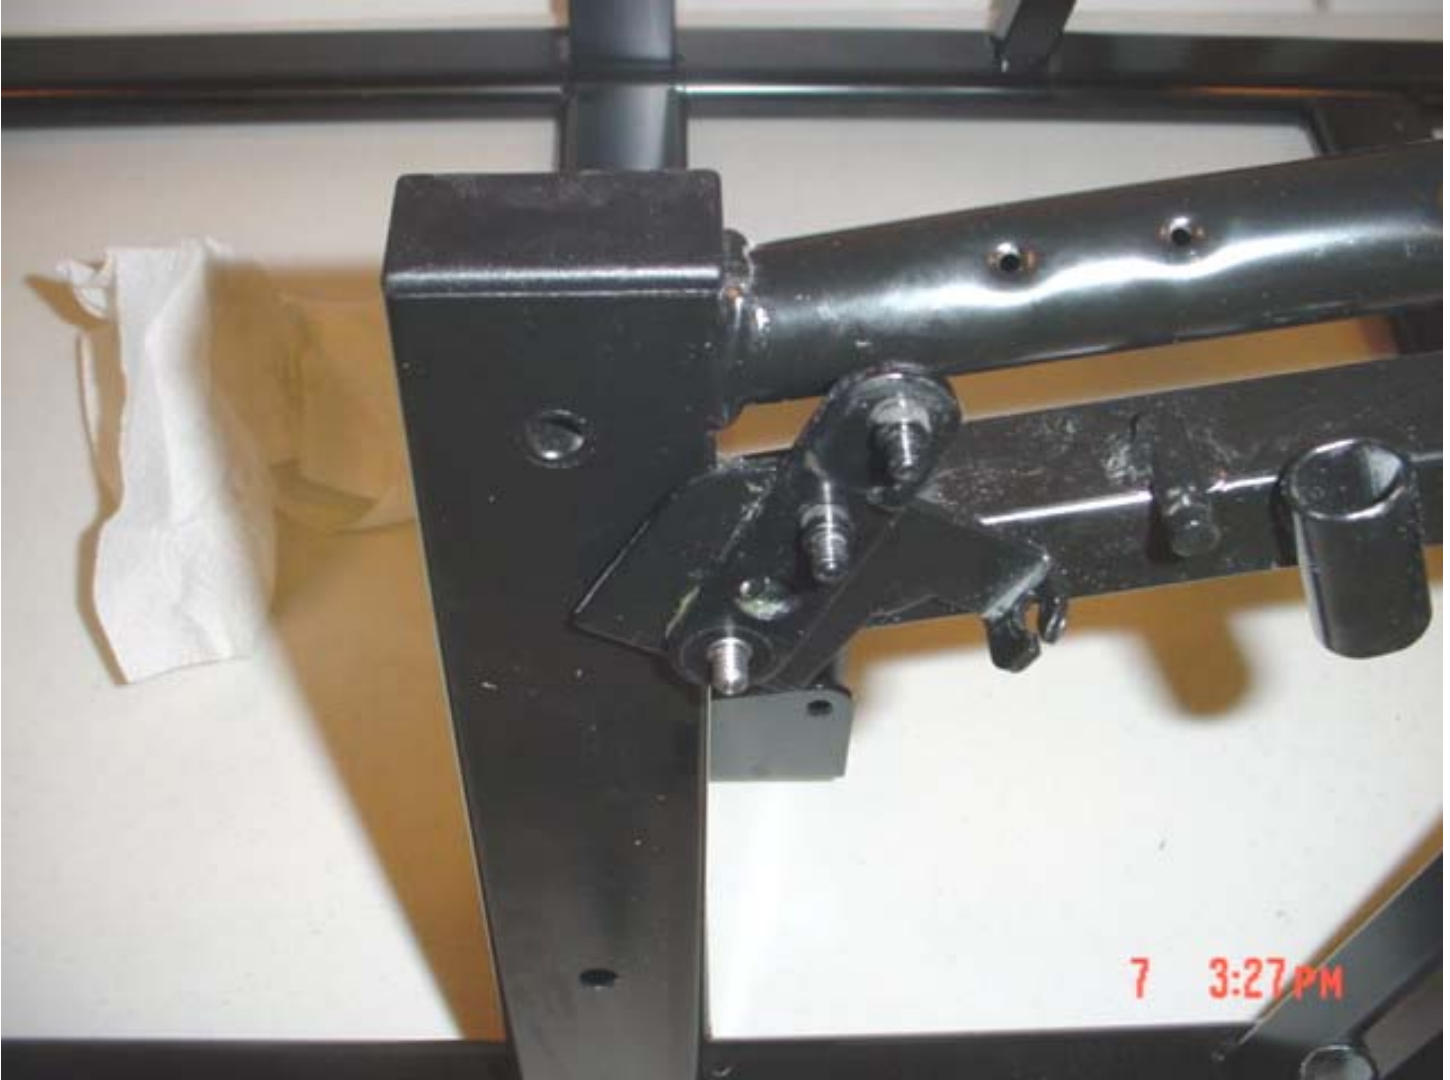
Process Complete, reinstall the outer bracket

Repairing the bracket is now complete. You are ready to reassemble the handle, spring and the rest of the sub-assembly.
