## PHP 2030 Drive Block Assembly Replacement Instructions:

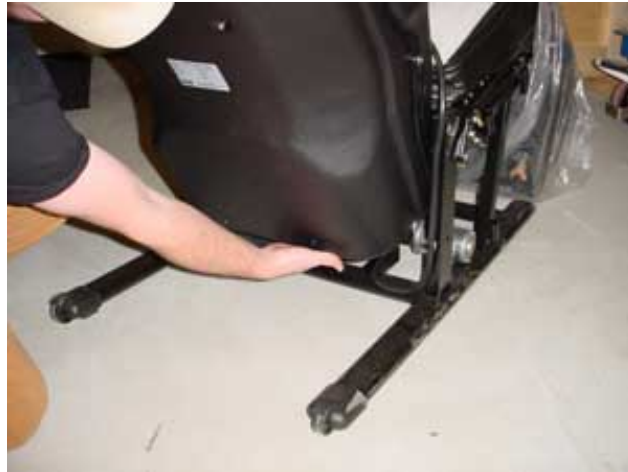
Lay the back of the chair down over the seat of the chair.

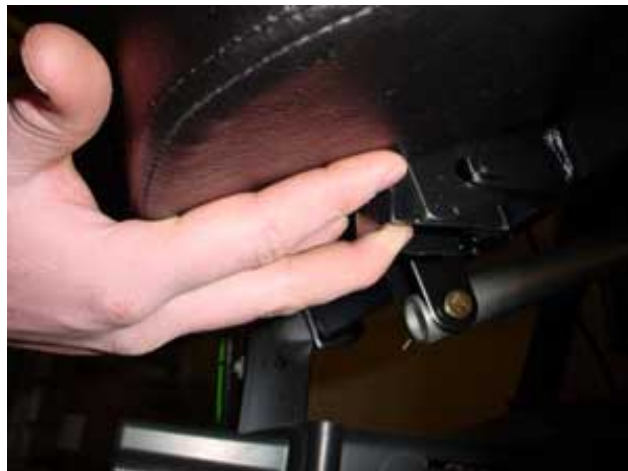
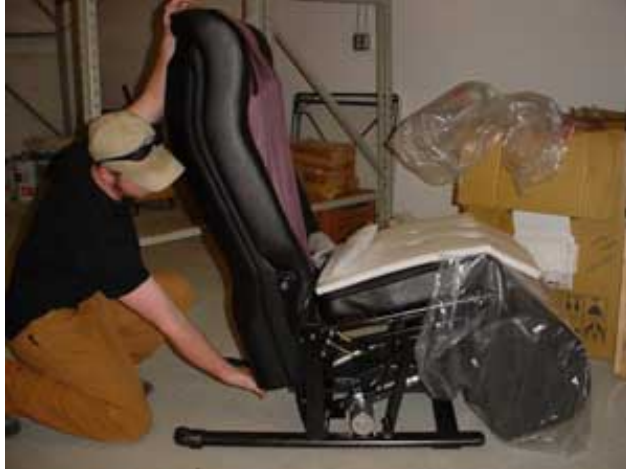
Reach under the back of the chair with your right hand.....about 6” in from the left side and about 4” in from the back cover. Locate the latch mechanism with a finger and pull latch out to release.

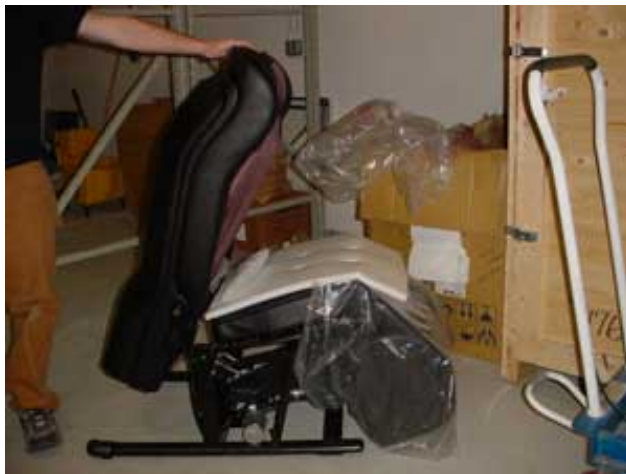
CAUTION, when the latch is release it will be free weight and will pivot.  
Hold the top of the chair and lay forward gently.

Hold onto the seat back until it is firmly lying on the seat.  
*DO NOT ALLOW chair back to 'drop' unsupported onto the seat.*

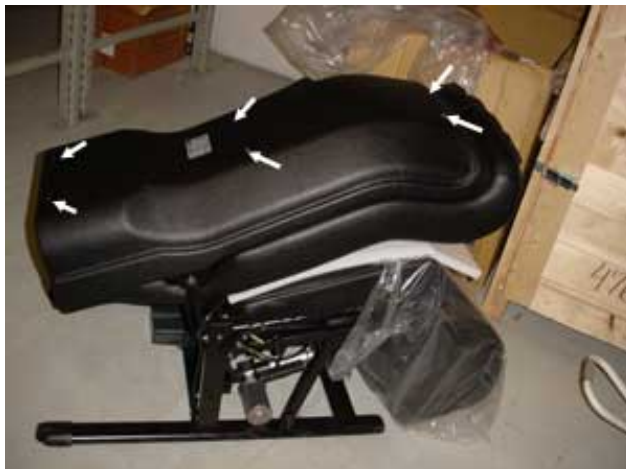
**Step 2**

Once the back of the chair is folded down and you are ready to begin, locate the six screws holding the back cover on.

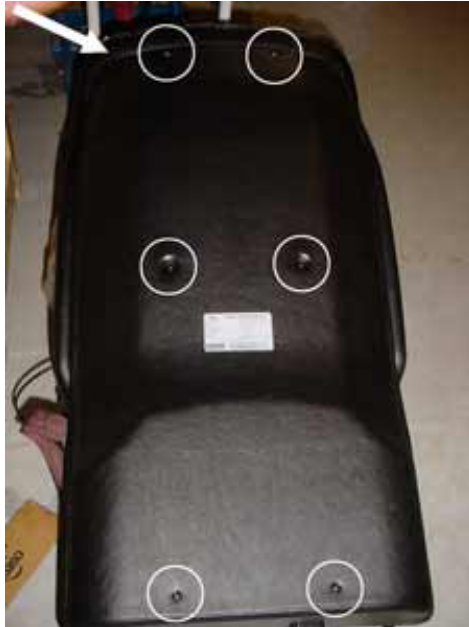
Using your # 2 Phillips screw driver remove the six screws.  
Lift the back cover up and off and set aside.

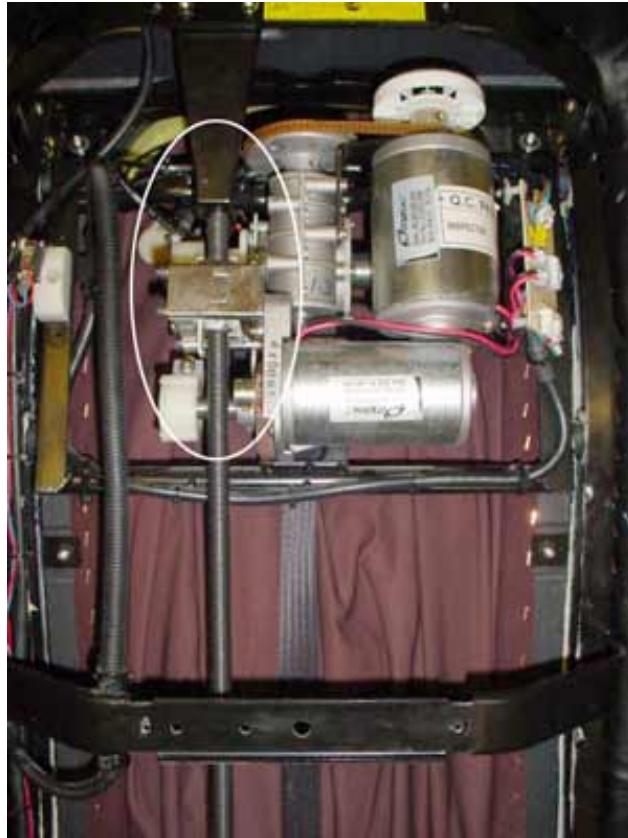
Locate the drive block assembly, indicated here by the arrow.

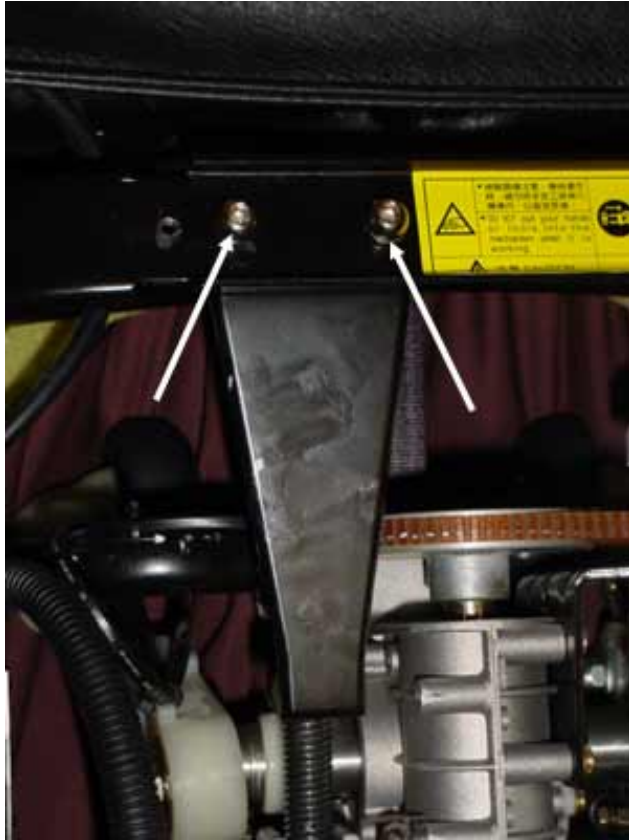
And shown here, the work area is encircled by the oval.

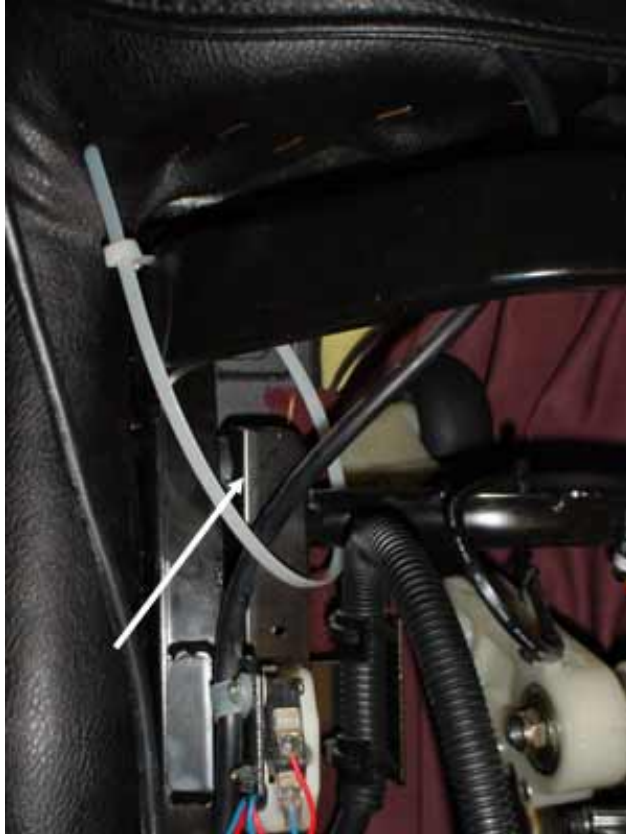
Begin by removing the two 5mm hex-head screws to release the top bearing retention bracket.

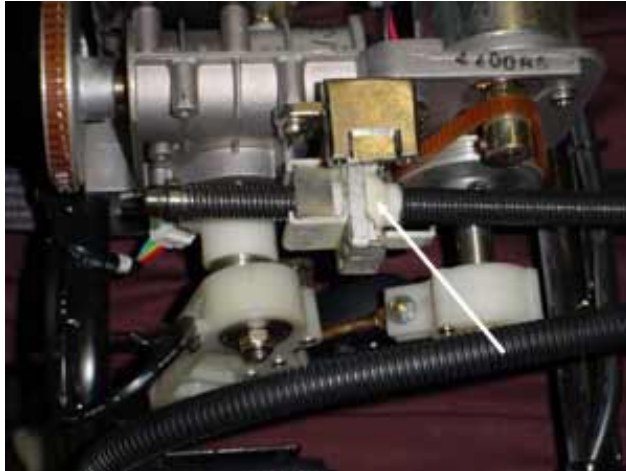
Now remove the four bolts that hold drive block assembly together using the 4mm hex key.  
**CAUTION** after taking the bolts and assembly apart the massage mechanism will only be held up by the one side. See next photo.

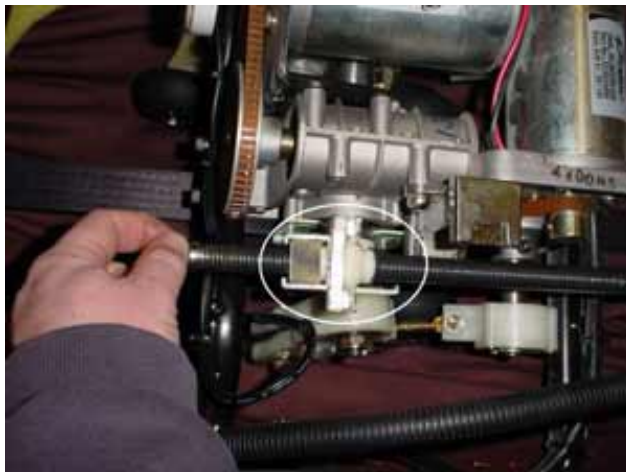
The drive block itself will be exposed after removing the metal brackets that surround it.

Pull the drive shaft lightly to the left while supporting the weight of the massage assembly until it is supported by the tie-wrap. Then, remove the broken drive block. If the drive block is severely broken, it may break in several pieces (check to ensure that all broken pieces are removed, otherwise, rotate the drive block towards the top (your left) until it unscrews from the shaft).
