Premier Health Products

Drive Block Assembly Damage

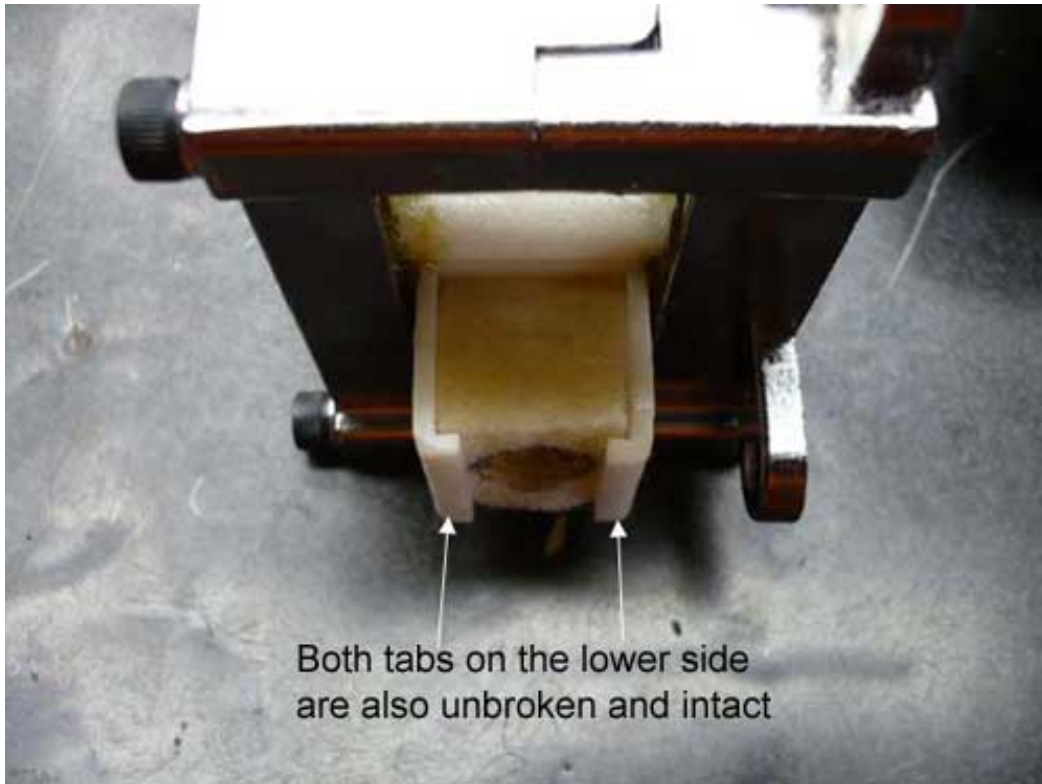
View of bottom side of drive block. There will be a large screw running from the top of the chair back to the bottom through the center of the drive block.

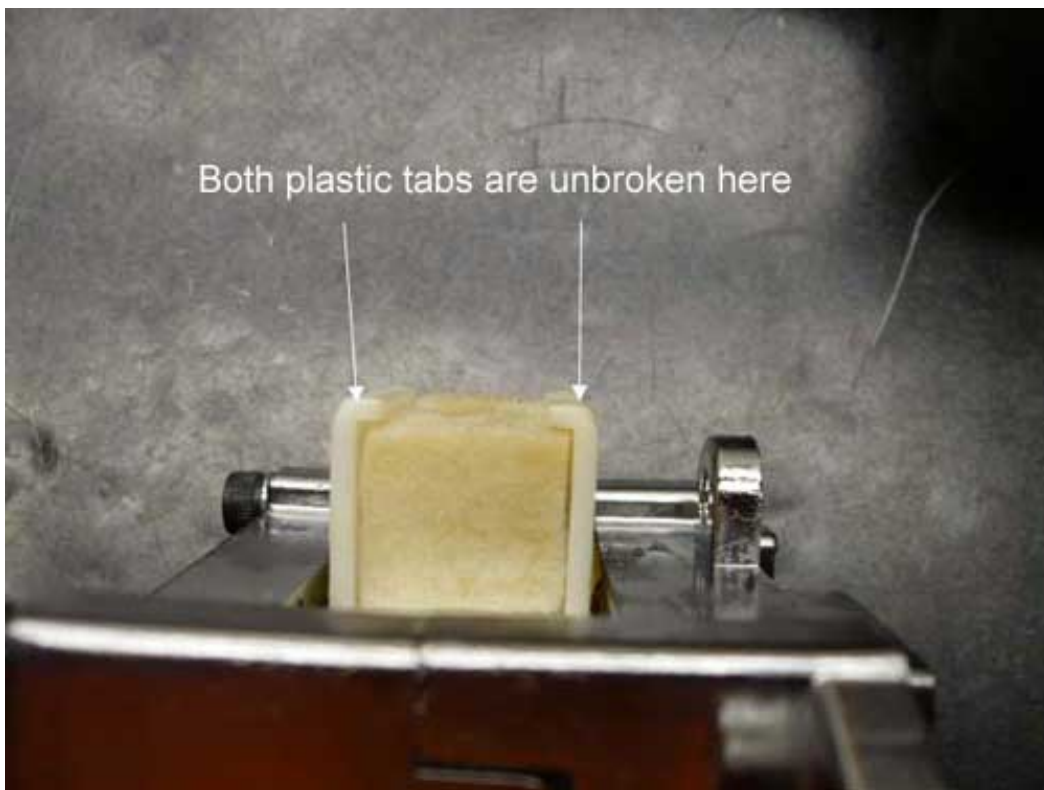
Both plastic tabs are unbroken here

View of the top of the drive block. There will be a large screw running from the top of the chair back to the bottom through the center of the drive block.
