Premier Health Products

Kneading motor or assembly damage

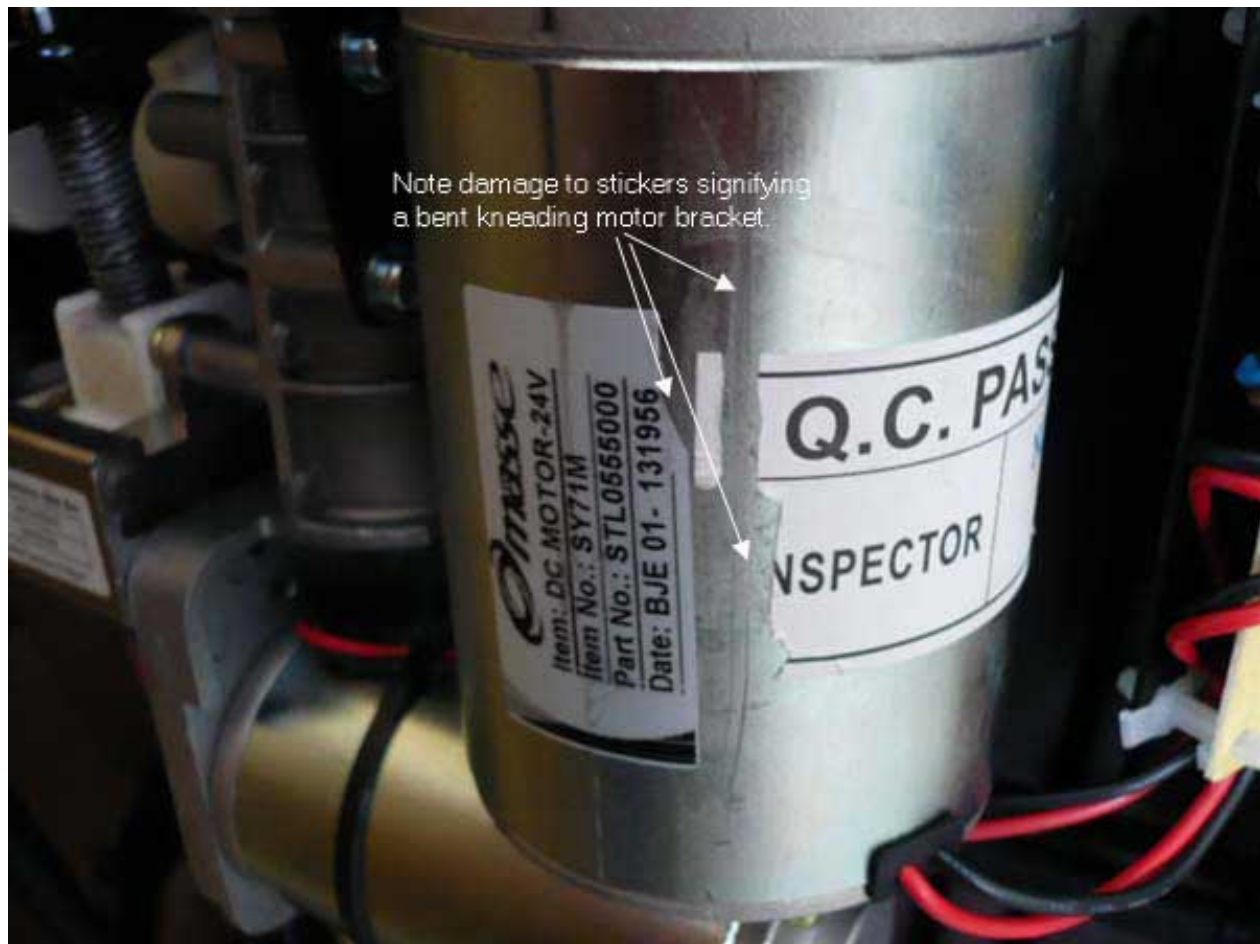
When hearing a knocking from the backrest of the chair during the kneading mode the first thing to check is the kneading bracket. Follow the instructions for [removal of the back cover](#) to get to the assembly

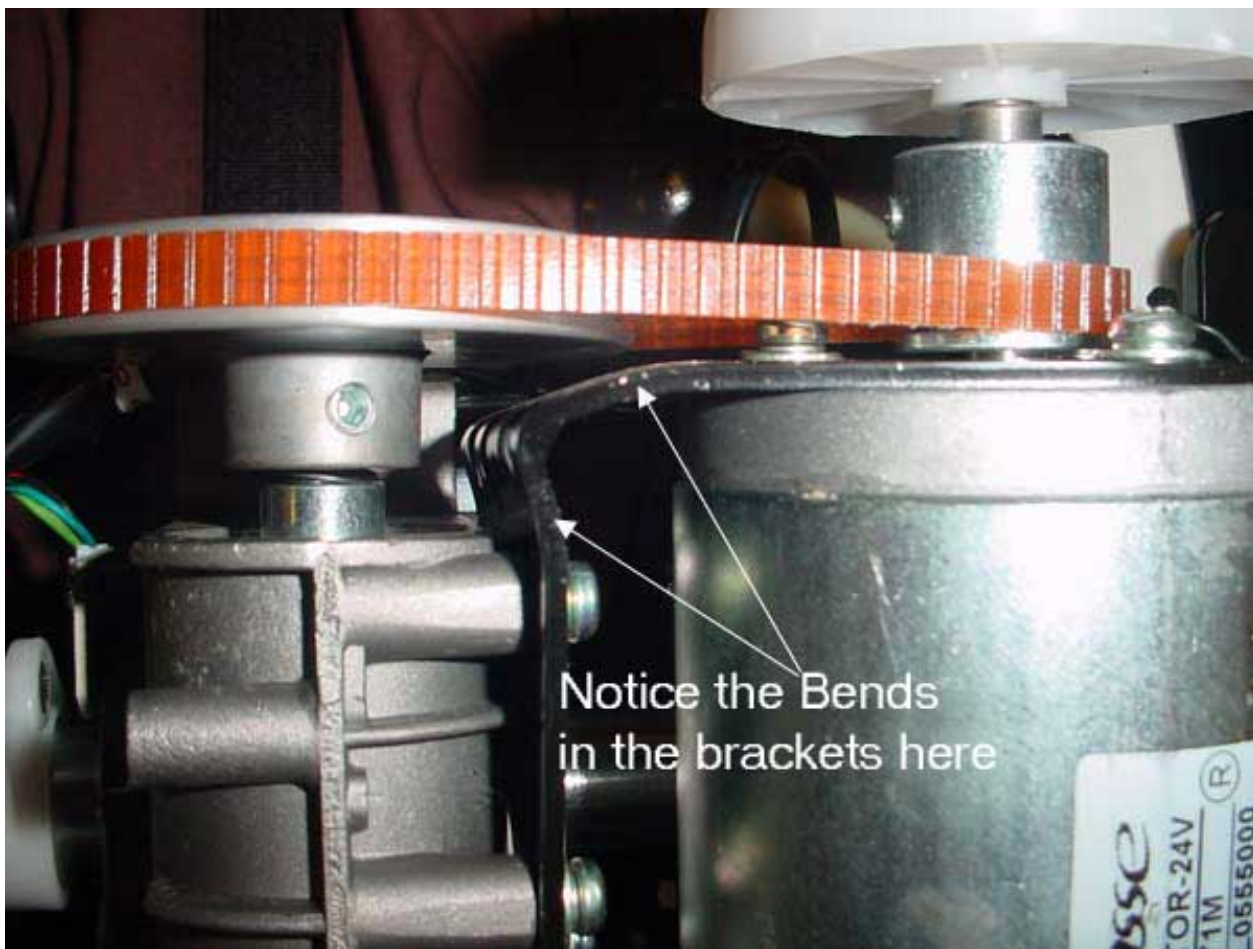
Regardless of the condition of the stickers the next thing to check is for damage to the kneading motor fixing bracket.

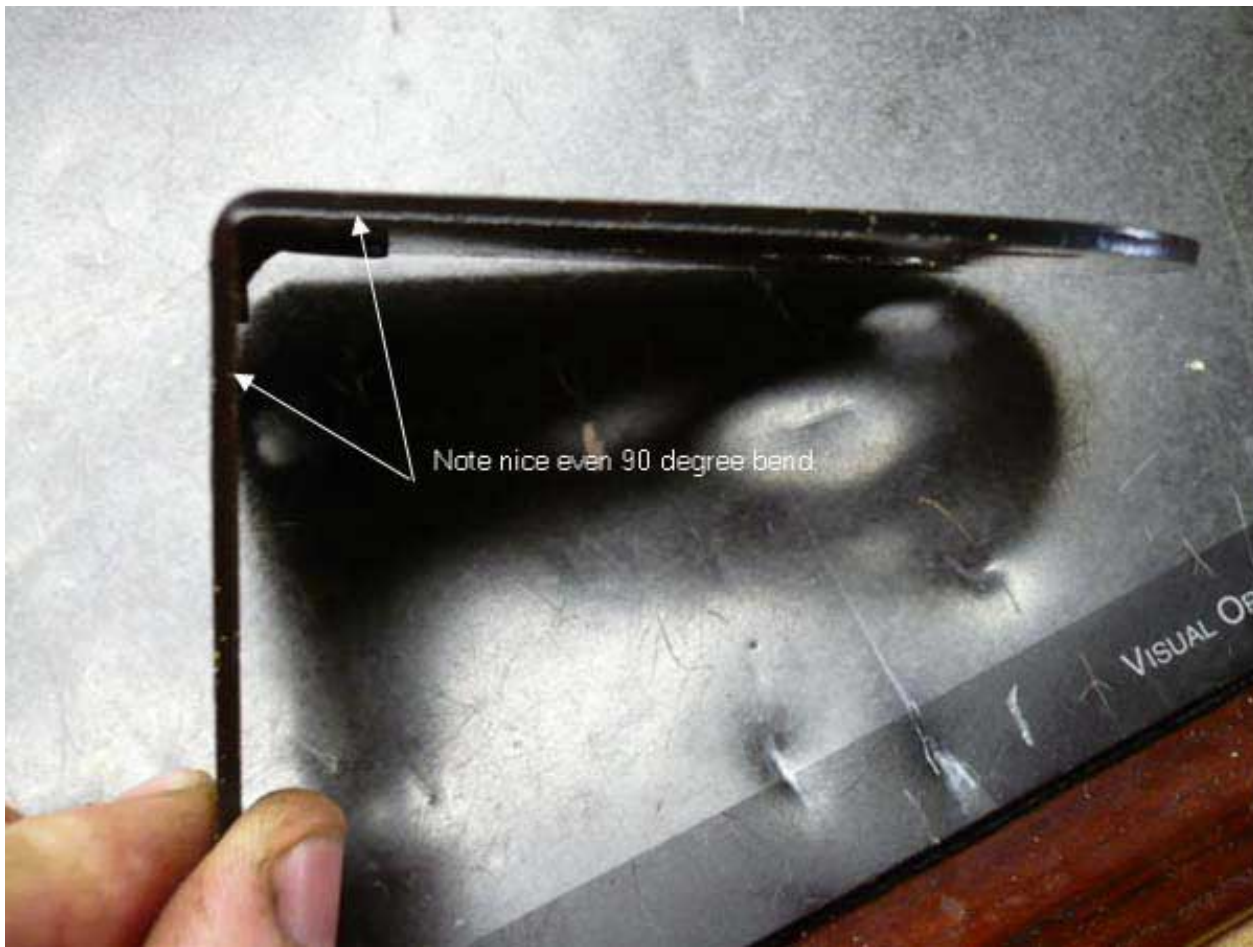
Compare the above picture to the one below of an undamaged bracket.

If the belt is not straight or the distances between the two screws and the motor above are not the same you may have a damaged kneading assembly.
