Checking the upper and lower switches for back carriage in PHP 2030

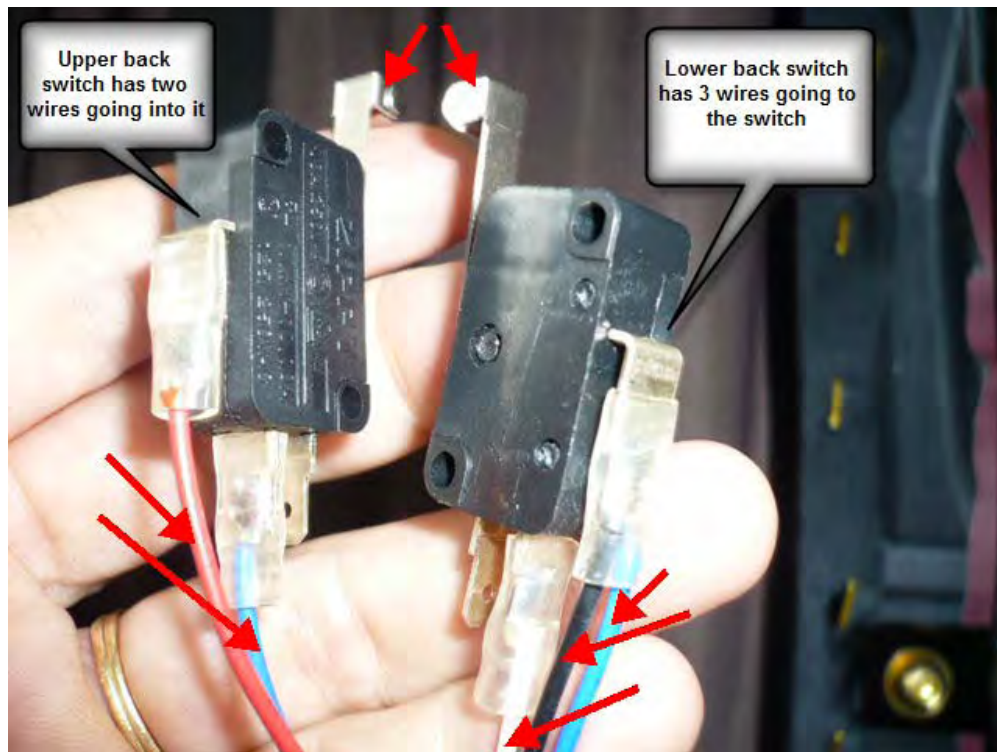
Hold switches in your hand. Determine which switch is for the upper stop and which is for the lower stop. See photo below:

Step 5) Turn chair on. As massage mechanism moves down, press the silver lever of the switch of the lower back switch toward the black portion of the switch until it clicks and keep lever held into the switch. If the massage mechanism stops and reverses directions, the switch is good and you can release the switch lever. As the massage mechanism travels back up the drive rod, test the upper back switch the same way.

If the switch you are clicking closed does not stop the message mechanism, quickly try the other switch. If the message mechanism still does not stop and change directions, turn the chair off and phone us.
