## PHP 2030 Backrest Recline Motor Replacement.

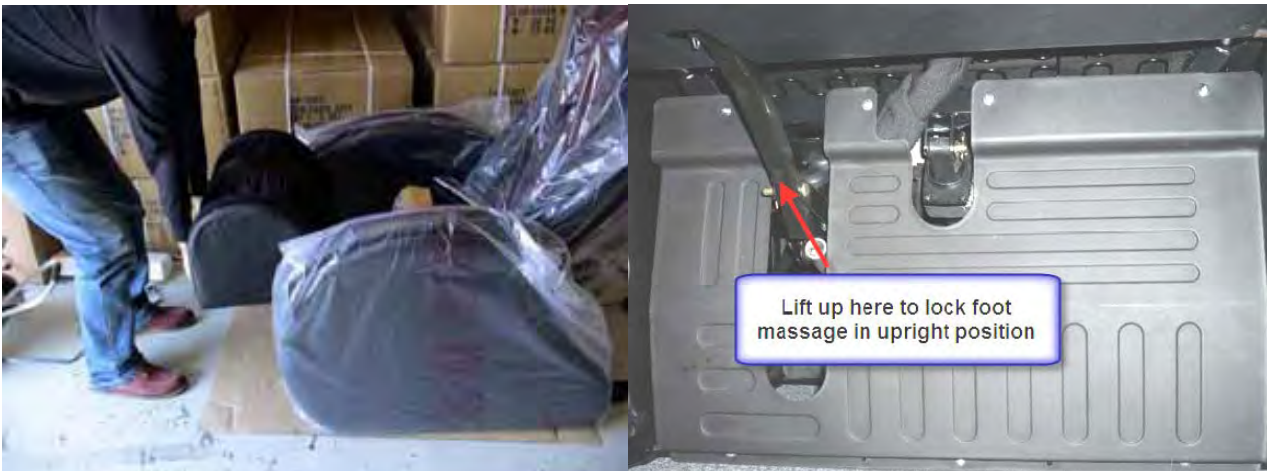
Step 1) Lock the leg rest assembly up. This will allow increased access to the working area

Lift the leg rest up and, while holding it up....use your left hand to push the locking mechanism (square tubing) up. Release your hold on the leg rest assembly. The entire assembly should remain up for better access to the work area. (After completion of the entire task, lower the leg-rest by simply lifting the entire assembly up which will automatically release the lock).

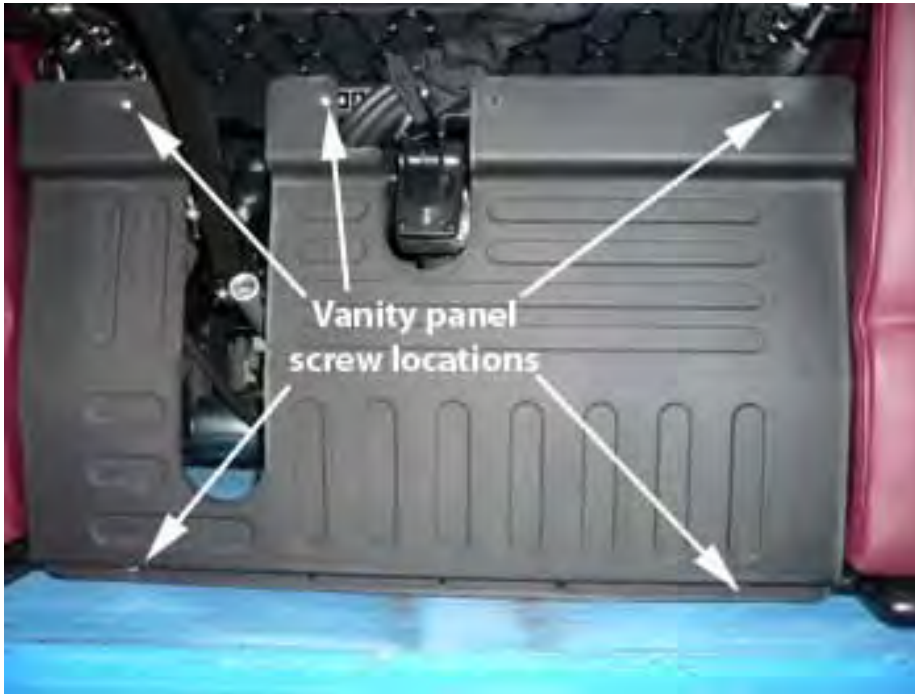
Step 2) Remove all Phillips screws holding vanity panel to chair frame.

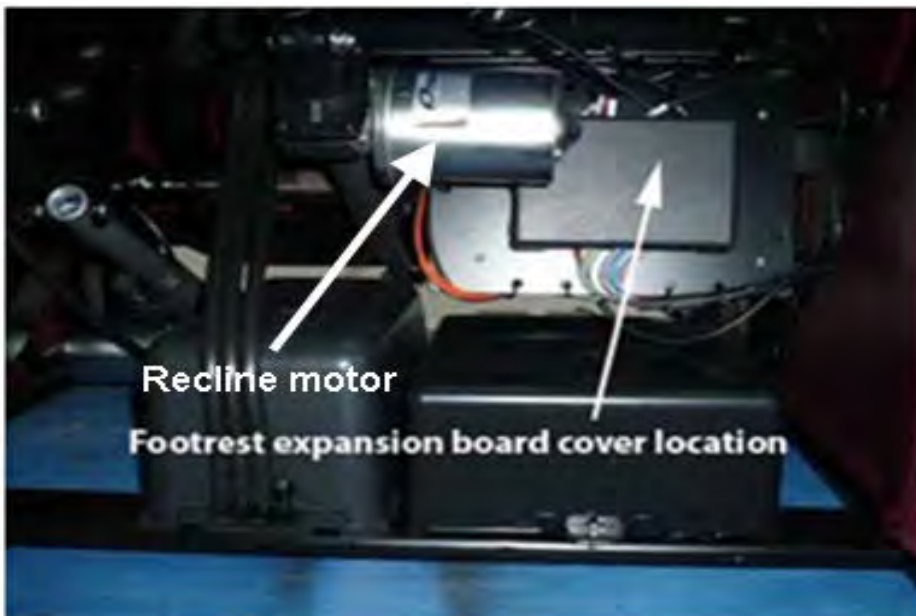
Step 3) Remove the expansion board cover. The expansion board is located in the upper right corner behind vanity panel cover.

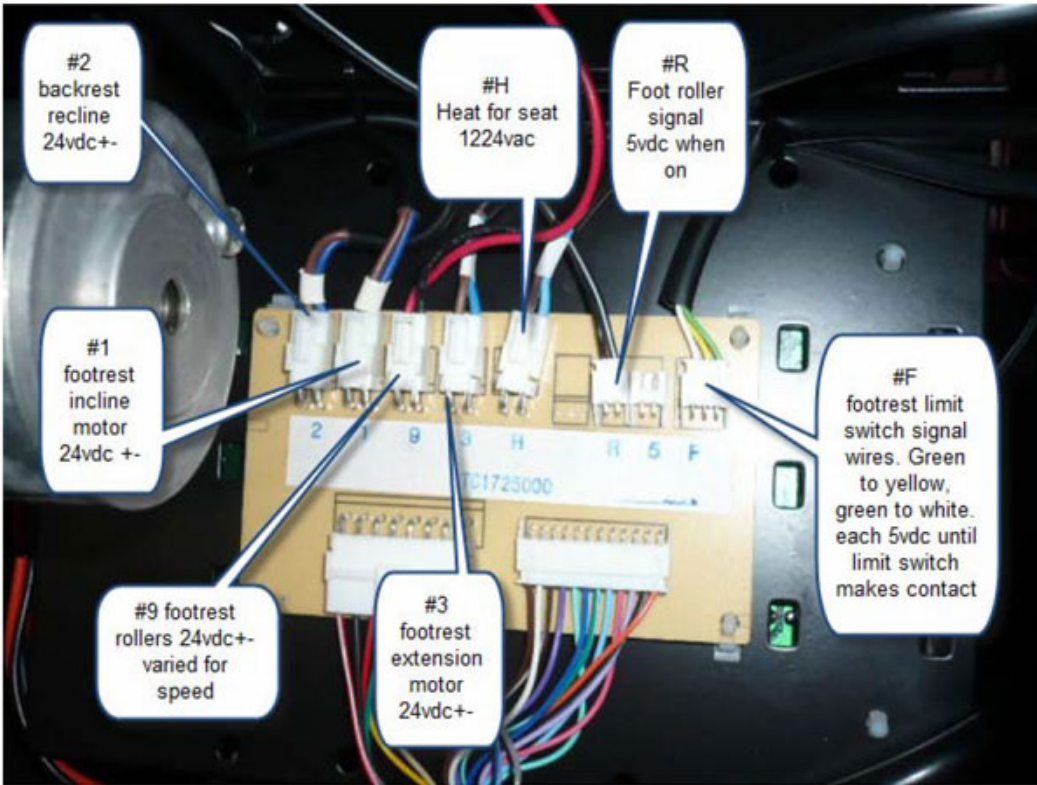
Step 4) Locate the #2 connector which is farthest left connector. This connector is for the recline motor

Step 5) Disconnect the # 2 recline motor connector.

The circuit board will look like this.

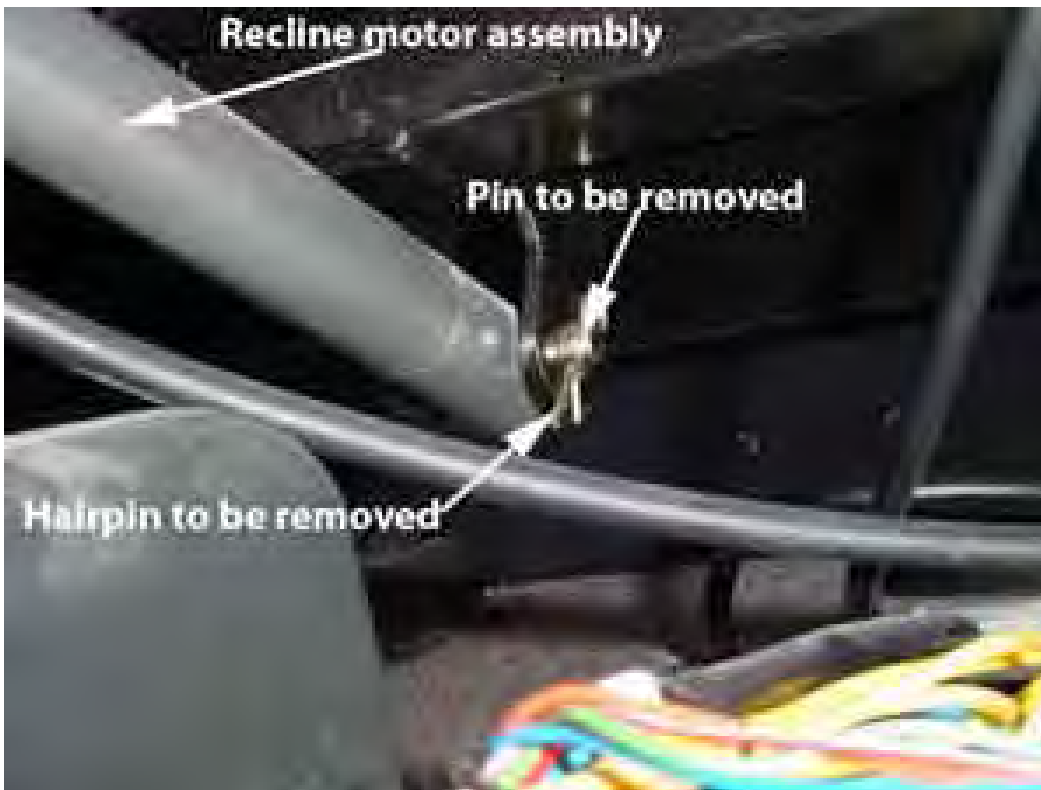
Step 6) Remove the cotter pin and pin in the rear of the recline motor

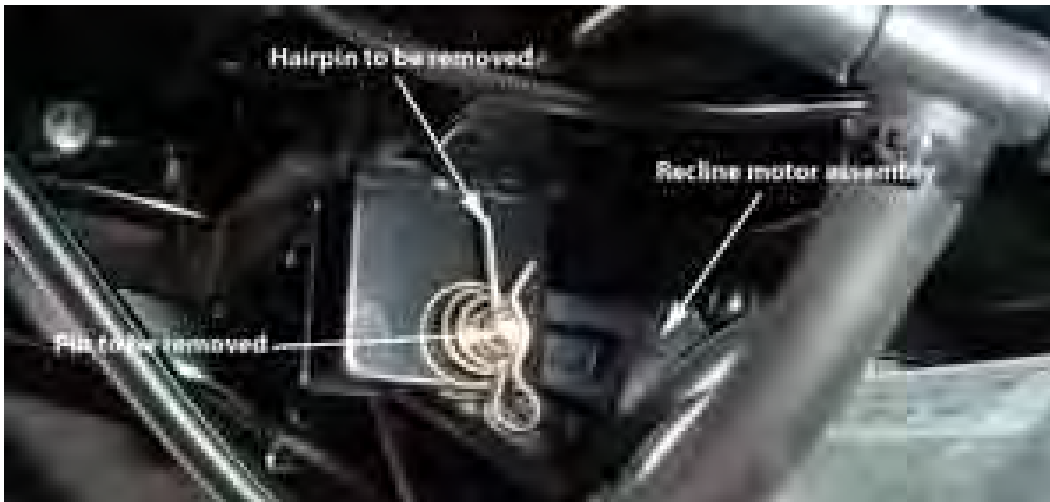
Step 7) Remove the cotter pin, spring and pin in the front of the motor and remove the motor from the chair.

Install the new motor by reversing these steps and rerouting the wire the way it originally was and zip-tying it back to the frame of the chair.
